# 155-mm Howitzer Malfunction Investigation: A Laboratory Study of the Igniter Train Operation

ARL-TR-2106

November 1999

# **Army Research Laboratory**

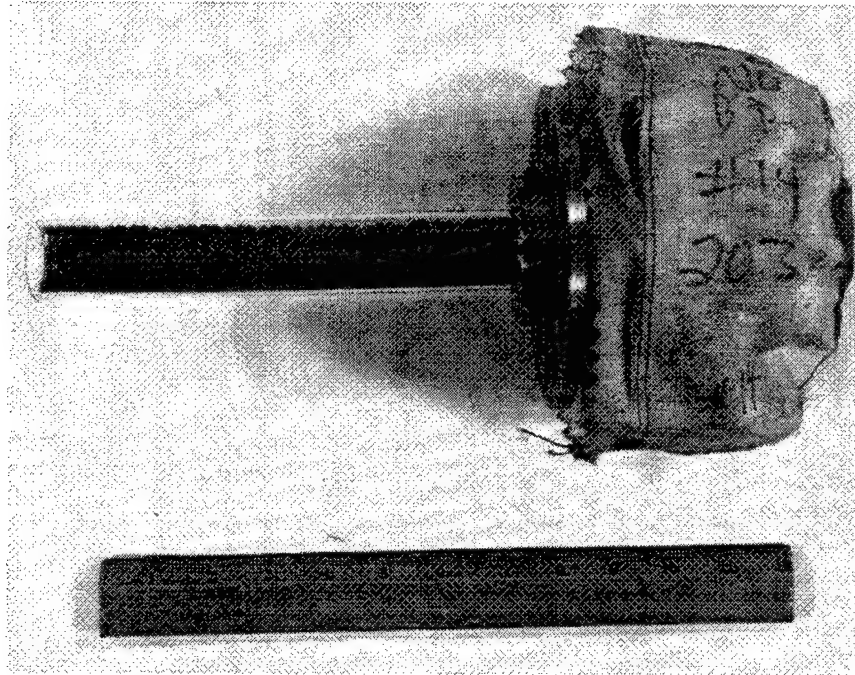
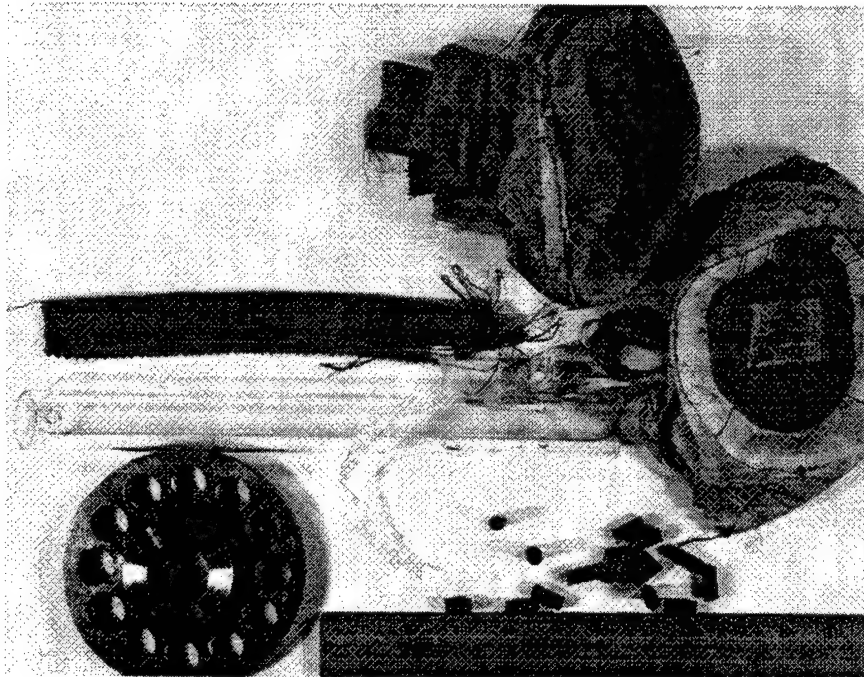
An exploded view of a typical charge can be seen in Figure 4(b), with a few representative grains of inert propellant. In this case, both the snake and the base pad are empty. An assembled view of this charge can be seen in Figure 4(a). It should be mentioned here that, for Runs 1-23, the center of the charge was carefully aligned with the primer output spit hole. Later runs were directed at testing the concept that misalignment of the charge could contribute to the hangfires.

**Figure 4. Fully Assembled Igniter Simulator Charge Views:  
(a) Normal and (b) Disassembled.**

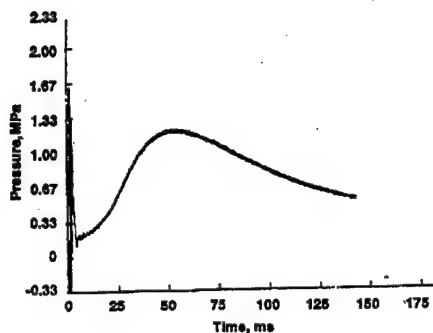
**3.1.2 Run 4.** Ignition delays and pressures are listed in Table 1. The M82 primer pulse was a distinct event and can be separated from the operation of the base pad. Note that Gauge 3, located directly in line with the primer, sees a much larger pressure than Gauge 1 or 2. Figure 5 is a pressure-time curve for Gauge 3. The pressure pulse from the M82 is clearly seen at about 3 ms. The Diode 1 signal is shown in Figure 6. The M82 light output is observed at around 3 ms, followed by the base pad light output, which saturates the system. The pressures measured in these

**Figure 5. Pressure vs. Time for Run 4, Gauge 3. The 203 Base Pad With 28 g (1 oz) of Black Powder and a Conditioning Temperature of  $-54^{\circ}\text{C}$ .**

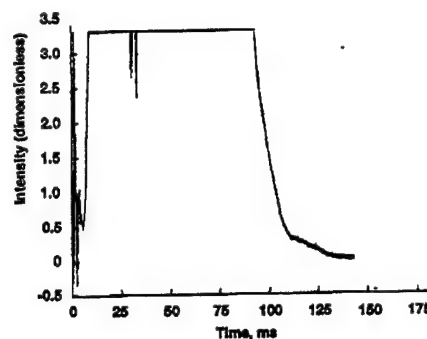
**Figure 6. Intensity vs. Time of Diode 1, Run 4.**

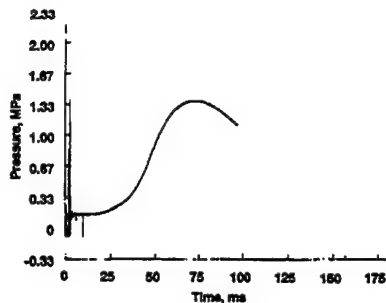
**3.7.1 Run 15.** This experiment was run as pictured in Figure 4(a) except that the base pad was emptied of black powder. The end of the snake was 8 cm from the base pad. Pressure-time trace is shown in Figure 17. It is seen that the delay is considerably longer than for the base pad alone, although far from hangfire conditions.

**Figure 17. Pressure vs. Time for Run 15, Gauge 3. The 203 Base Pad (Empty) and Snake, 50 g of Black Powder and a Conditioning Temperature of  $-54^{\circ}\text{C}$ .**

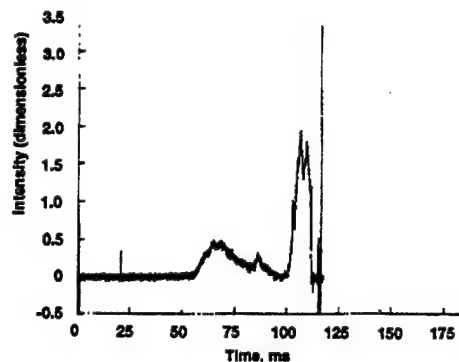
sink for the igniter output and lowers the pressure that would ordinarily be achieved. As a consequence, the chamber pressure from the snake and NC tube ignition was increased and the acrylic tube ruptured before the peak pressure was reached. Consequently, peak pressures were not recorded. The chamber ruptured at about 2.2 MPa (350 psi). Again, a nonuniform flamespreading of the snake can be seen in the pressure-time curves (Figures 21–23) with discontinuities at 60 and 110 ms. Because of the misalignment, the M82 pulse was not observed (Table 1 and Figure 23). The ignition of the snake can also be seen on Diode 2 (Figure 24); a small emission at 60 ms followed by a strong emission at 110 ms. These coincide with the pressure measurements.

**Figure 24. Intensity vs. Time for Run 27, Diode 2. The Sharp Increase in Intensity at 100 ms Corresponds to the Sharp Increase in Pressure, as Seen in Figures 21, 22, and 23.**

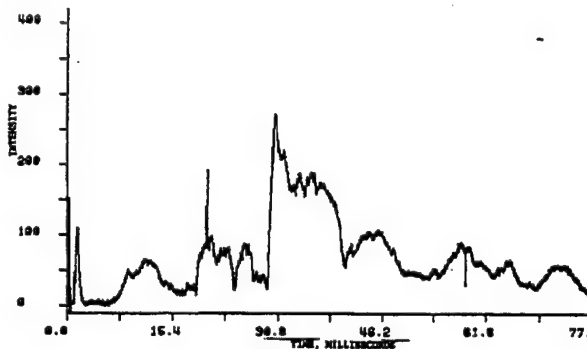
**3.14.2 Run 42.** Results of this test were essentially the same as Run 41. Figures 38 and 39 show the pressure-time curves. Figure 40 shows the signal from Diode 1. The light emission from the M82 primer can be clearly observed (1.5 ms) followed by light emission from the base pad (8 ms). This is also seen in Figure 41 for Diode 2. The pressure pulse transit time from one end of the chamber to the other can be found from Figure 42 ( $2.8\text{ ms} - 1.5\text{ ms} = 1.3\text{ ms}$ ).

**Figure 40. Intensity vs. Time for Diode 1, Run 42.**

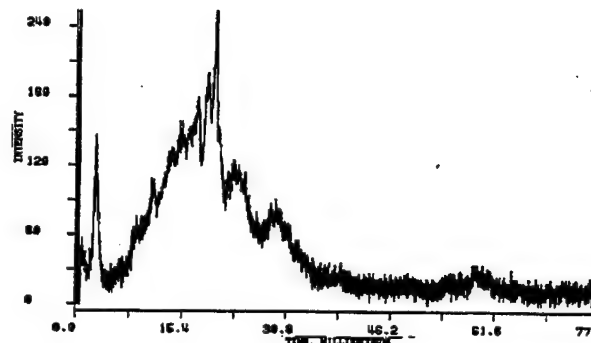
**Figure 41. Intensity vs. Time for Diode 2, Run 42.**

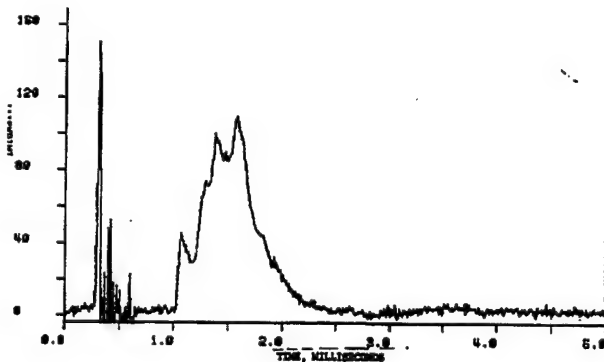
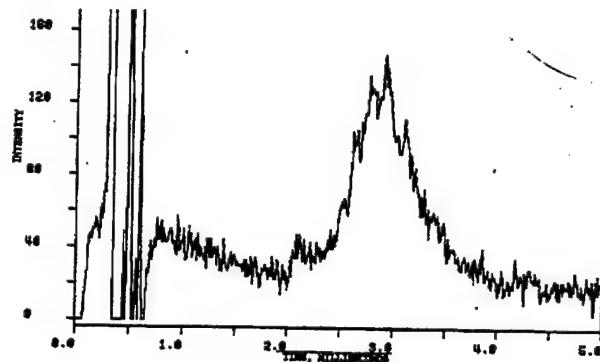
**Figure 42. Intensity vs. Time for (a) Diode 1, Run 42 (Peak Intensity for M82 Occurs at 1.5 ms) and (b) Diode 2, Run 42 (Peak Intensity for M82 Occurs at 2.8 ms). The Difference in Time Is Due to Transit Time of M82 Pulse Down the Center Core Tube.**
